AIRCRAFT ACCIDENT INVESTIGATION REPORT

Japan Air Lines Co., Ltd.
Boeing 747 SR-100, JA8119
Gunma Prefecture, Japan
August 12, 1985

Aircraft Accident Investigation Commission
Ministry of Transport

June 19, 1987

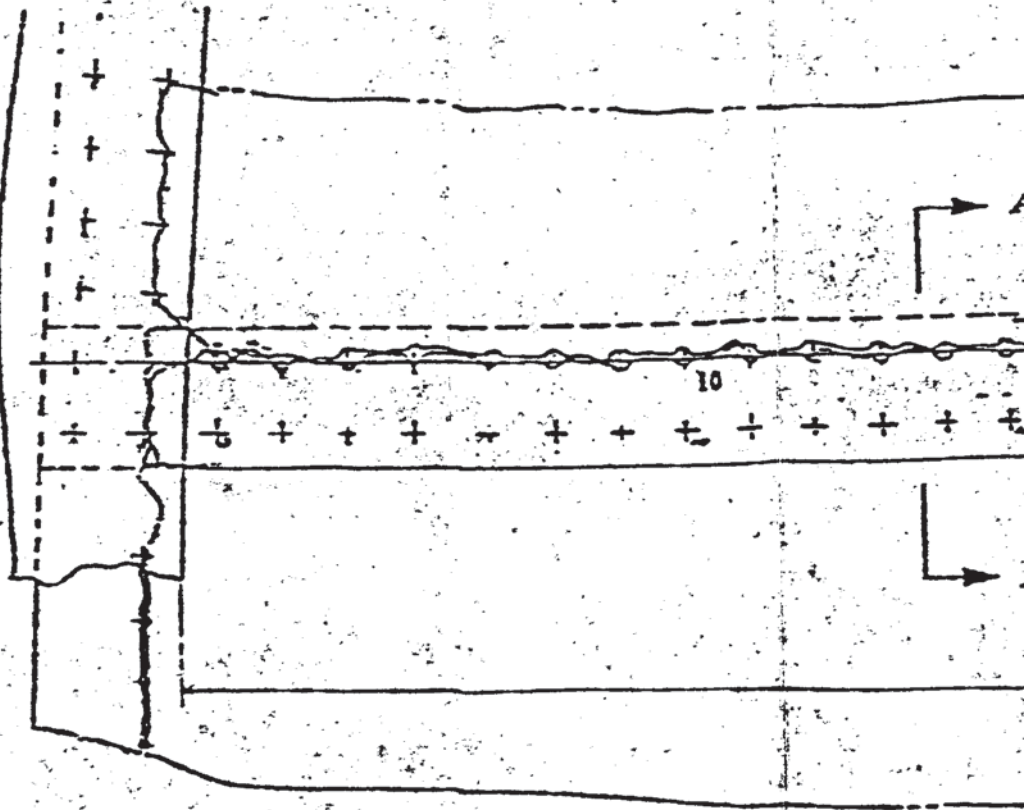
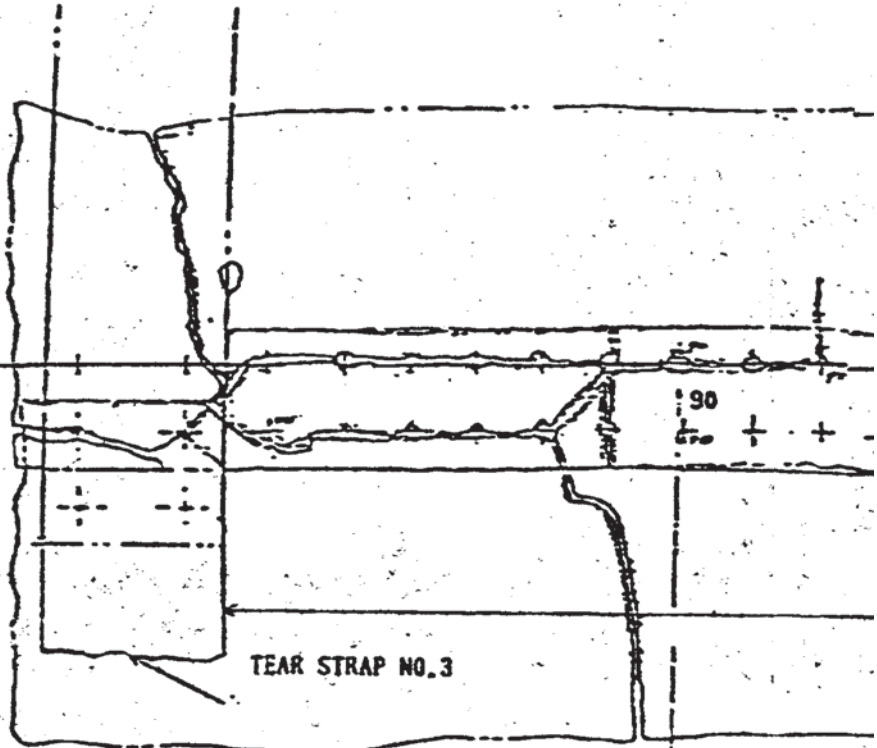
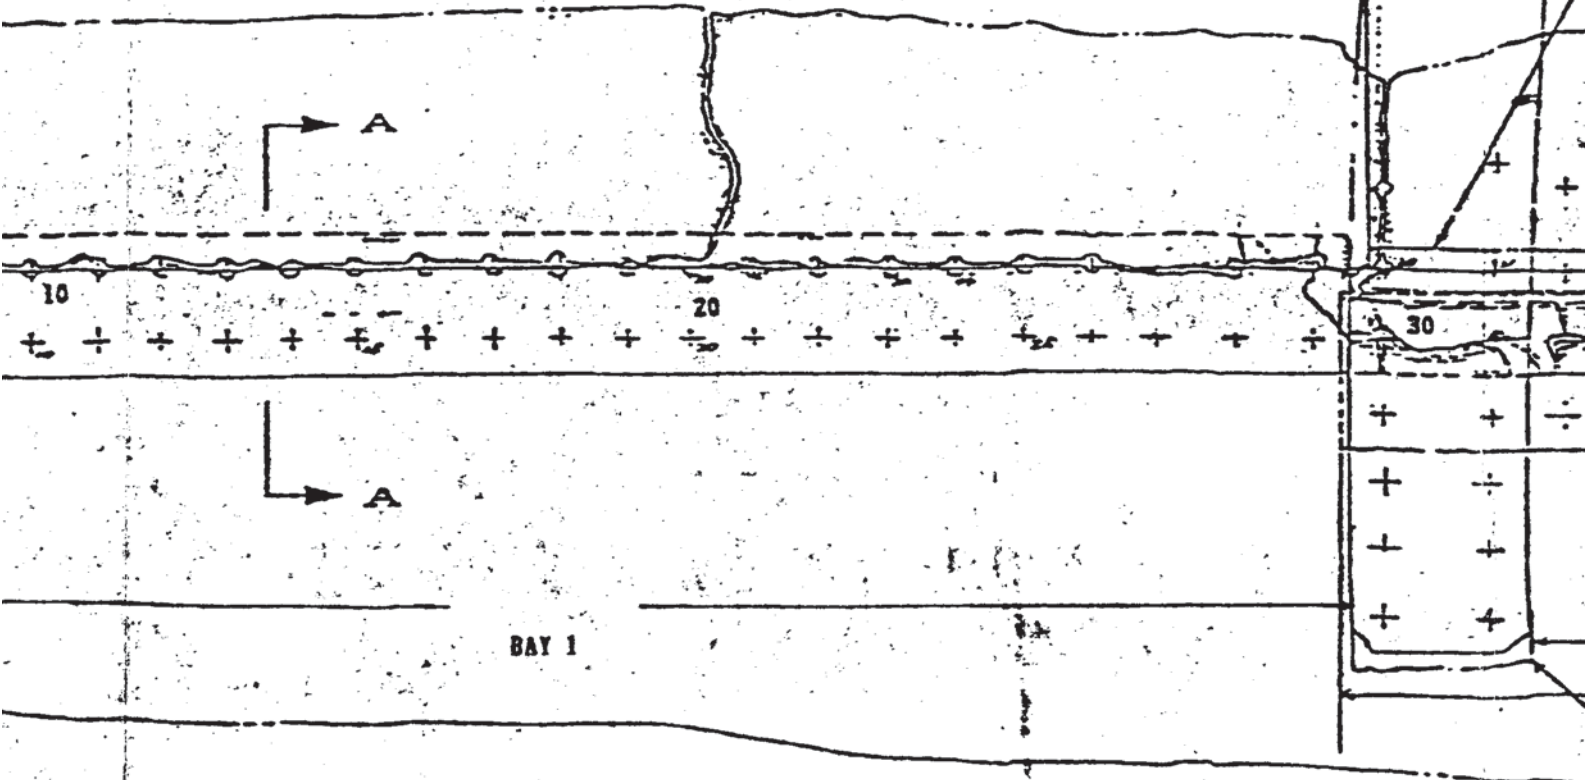
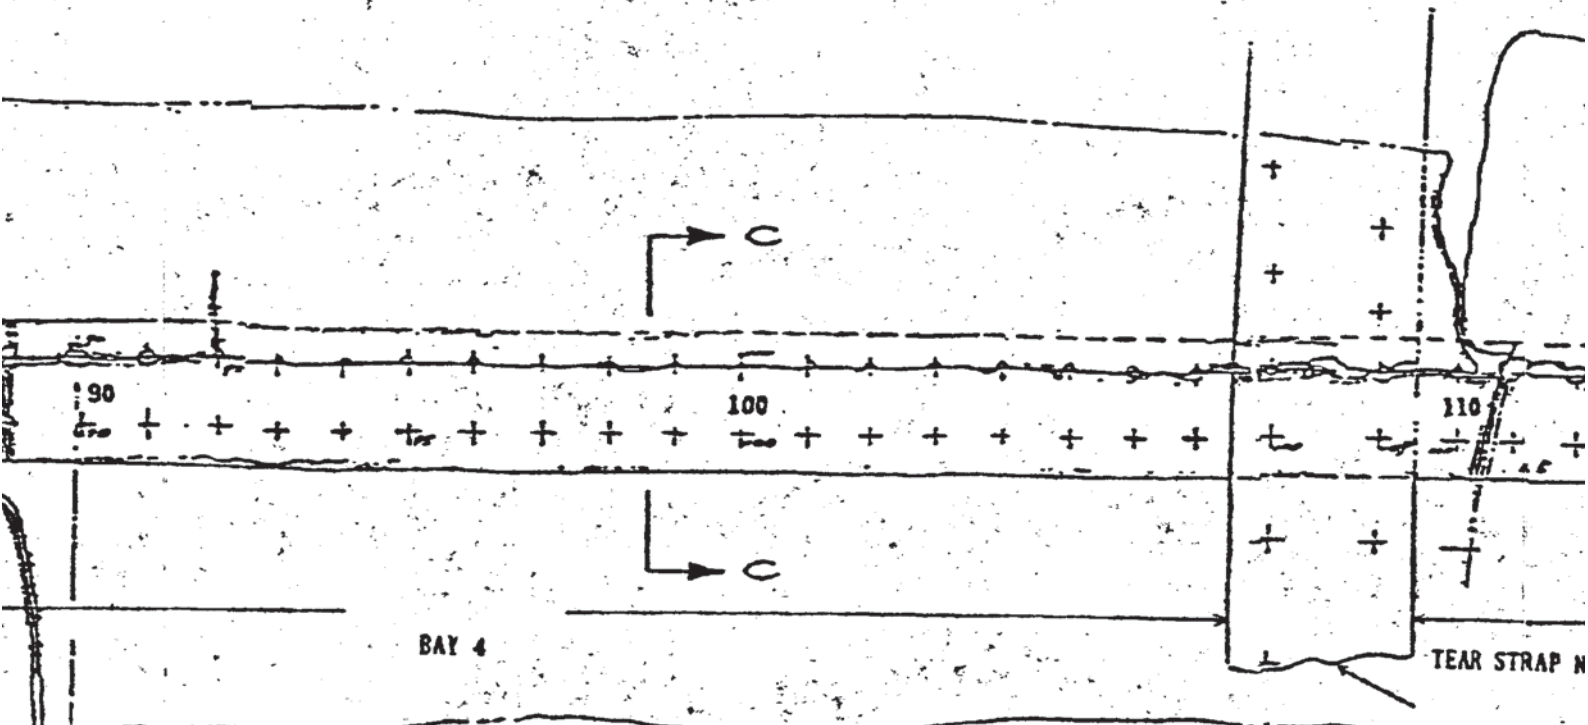
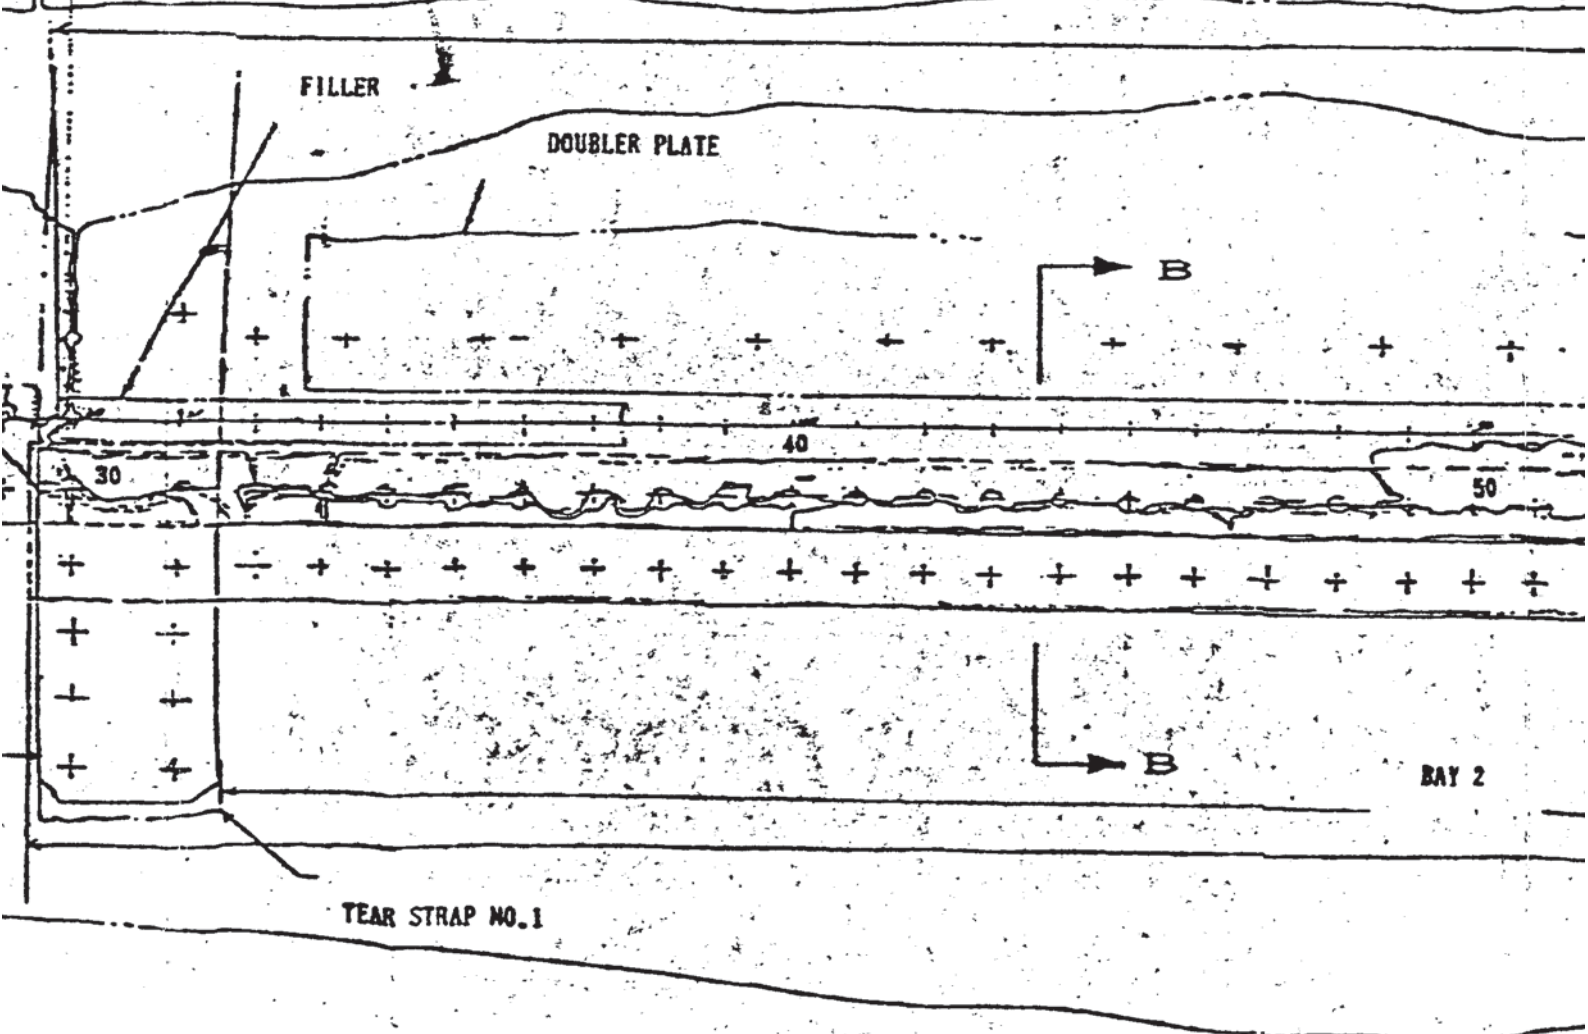
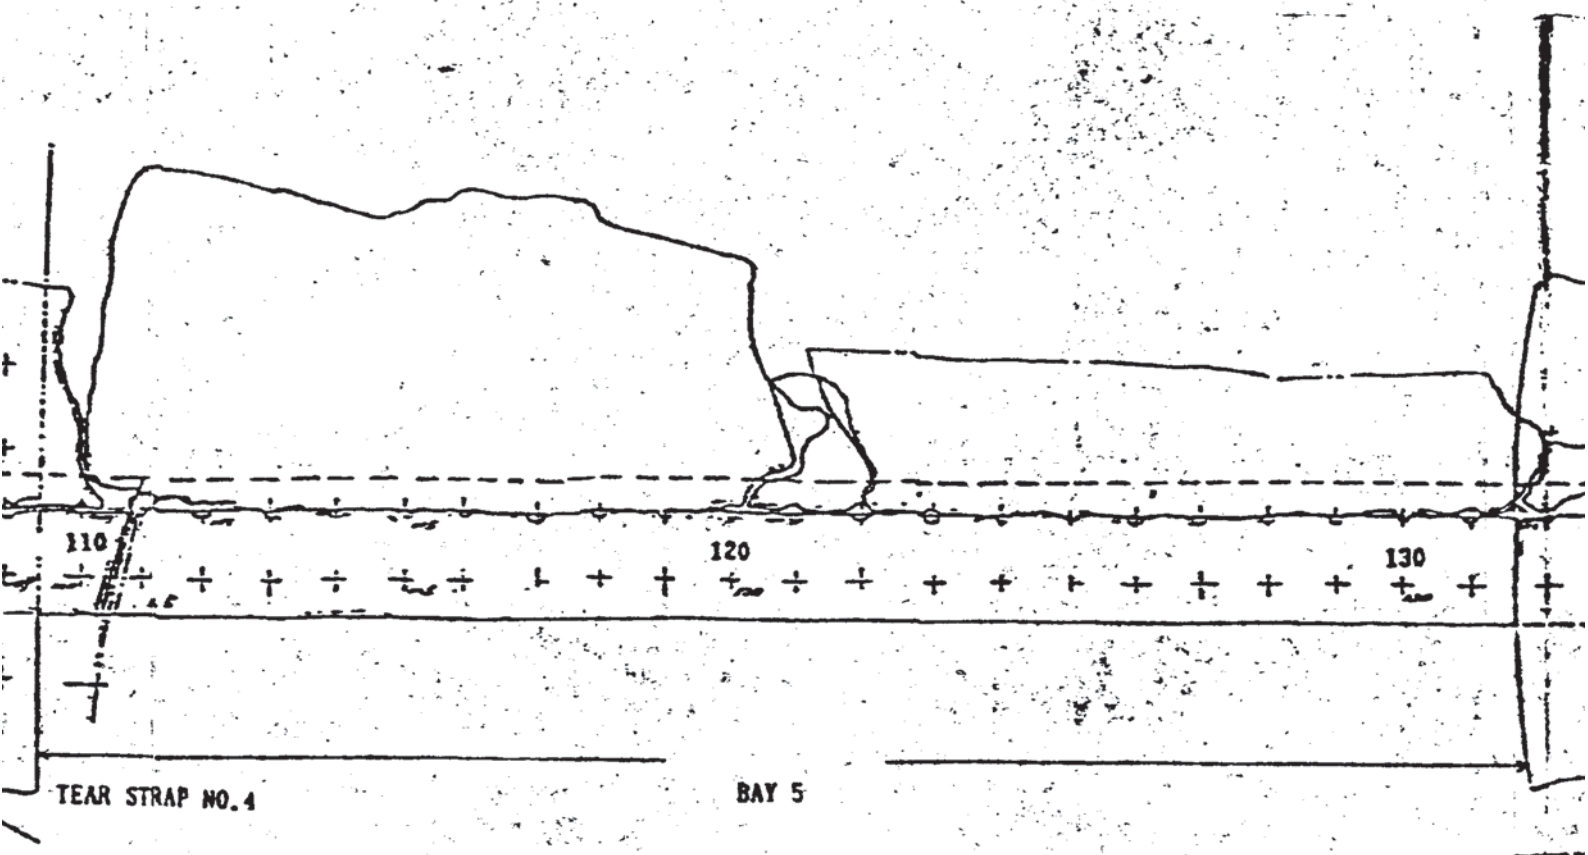
Figure-37 Fracture of webs along stiffener L18

Stiffener was failed at rivet #30 and #83.

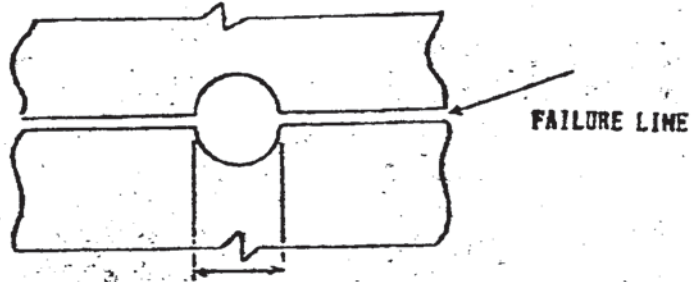
(c)

TYPICAL FRACTURE ASPECT

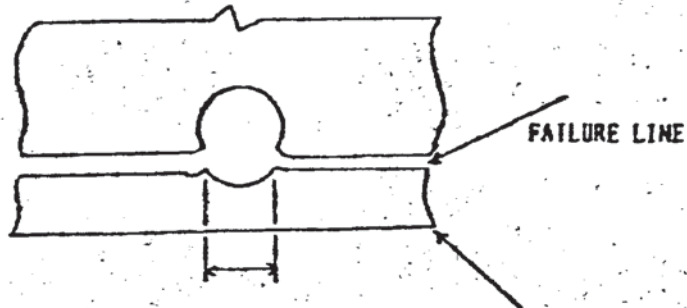
(d)

ASPECT OF FRACTURE NEAR EDGE OF PLATE

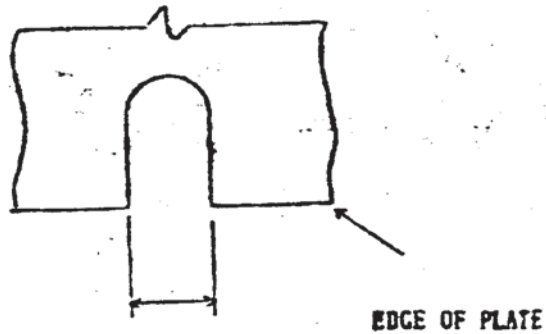
(e)

ASPECT OF SHEARING FRACTURE OF HOLE EDGE

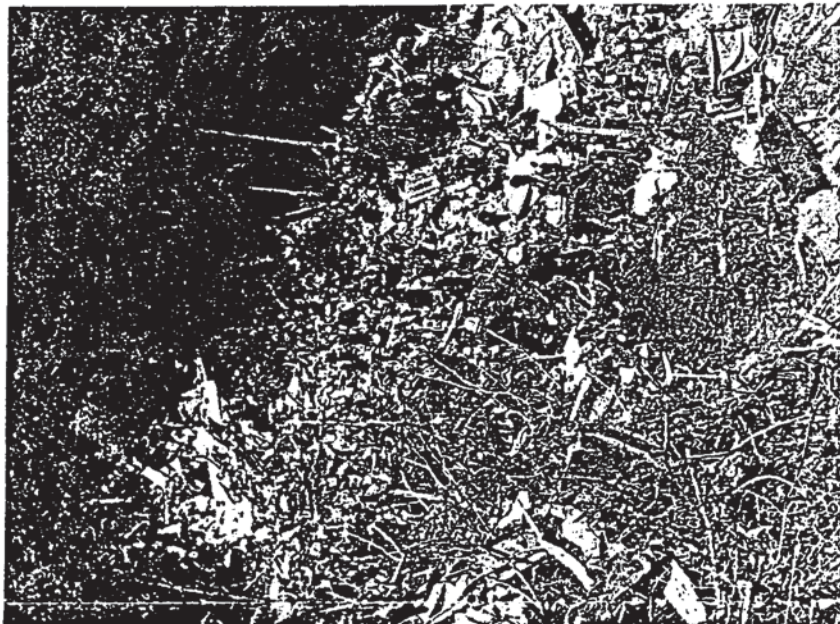
4 Debris of aft fuselage (1)

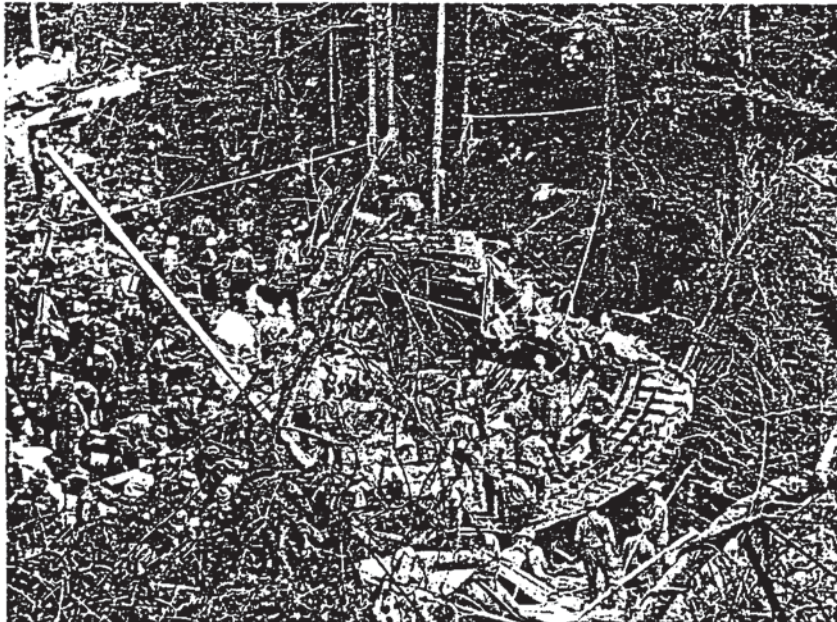
5 Debris of aft fuselage (2)

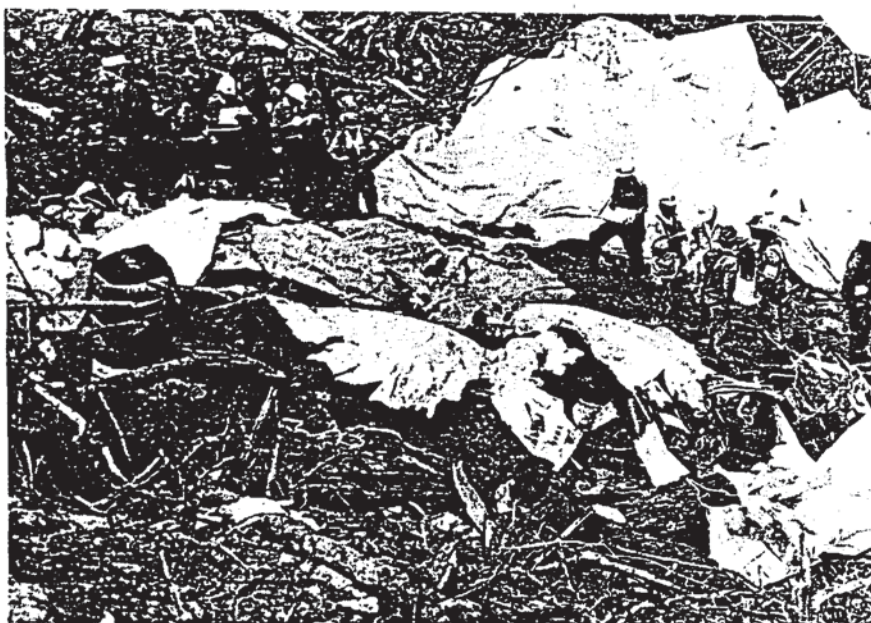
12 Recovered aft pressure bulkhead (1)

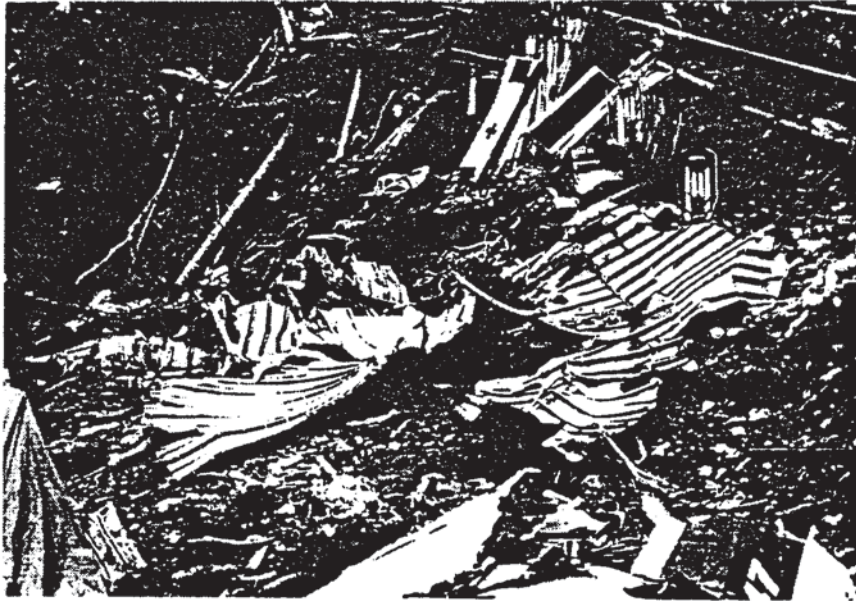
13 Recovered aft pressure bulkhead (2)

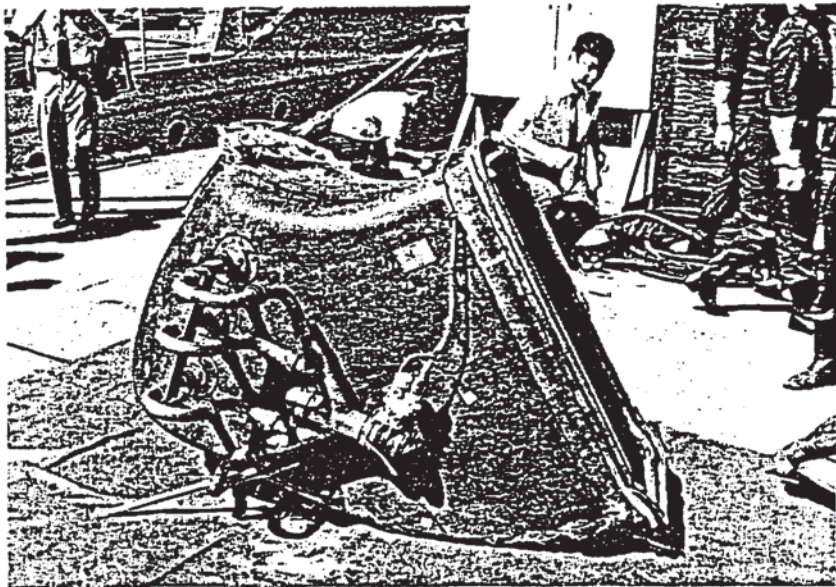
15 Part of vertical fin recovered from sea (1)

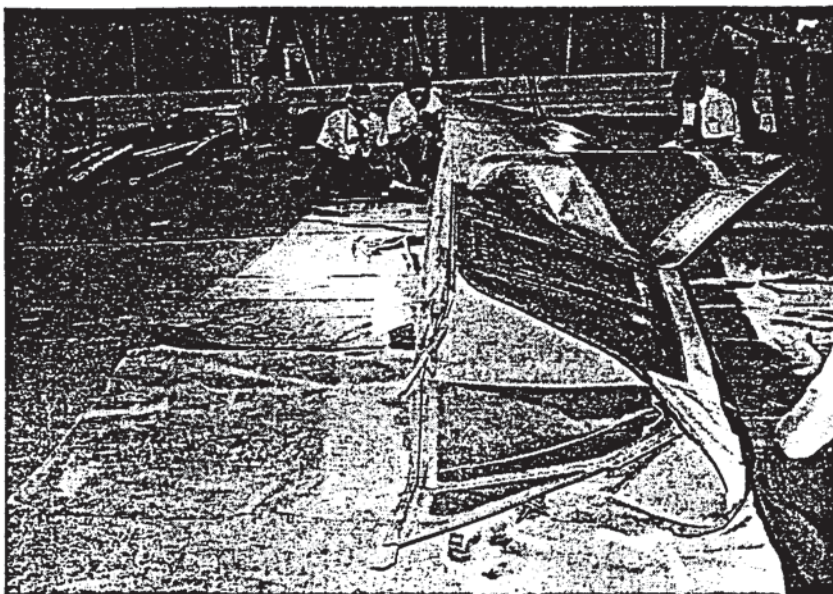
16 Part of vertical fin recovered from sea (2)

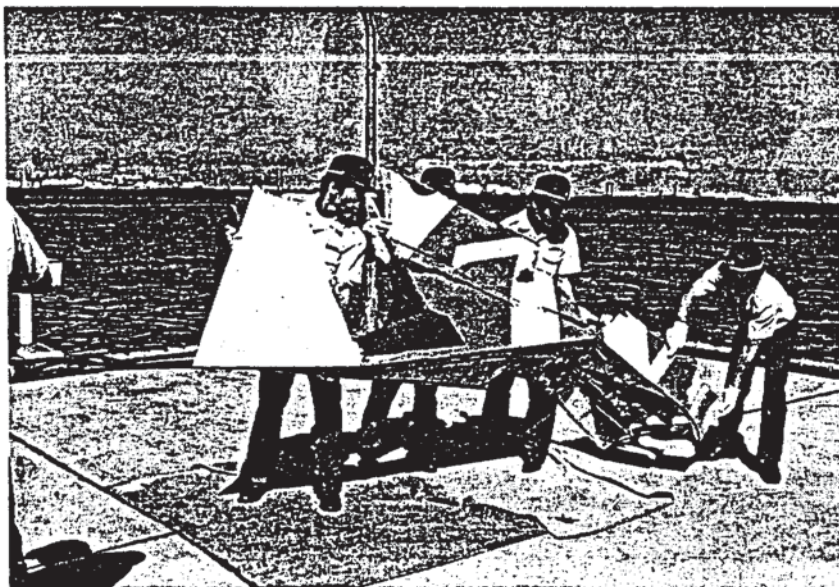
17 Wreckage discovered on flight path (1)

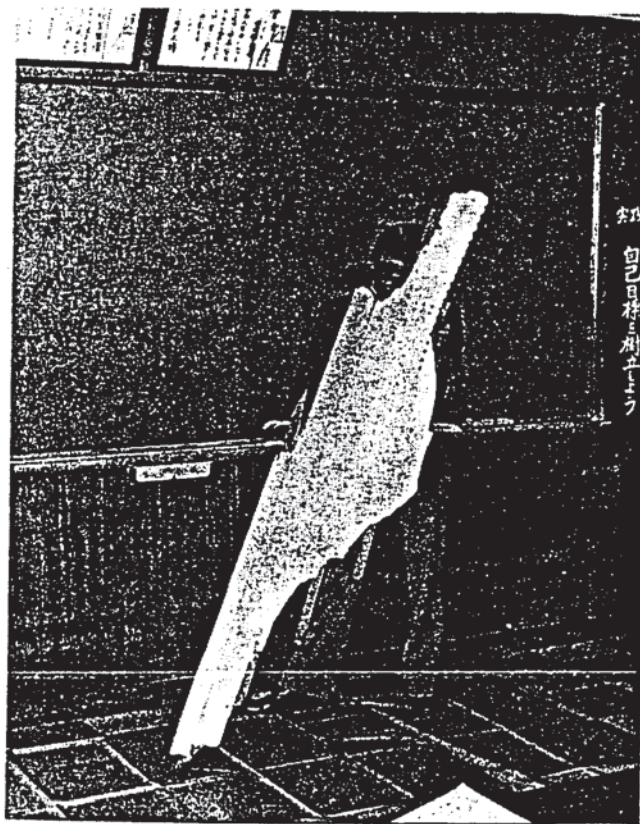
18 Wreckage discovered on flight path (2)

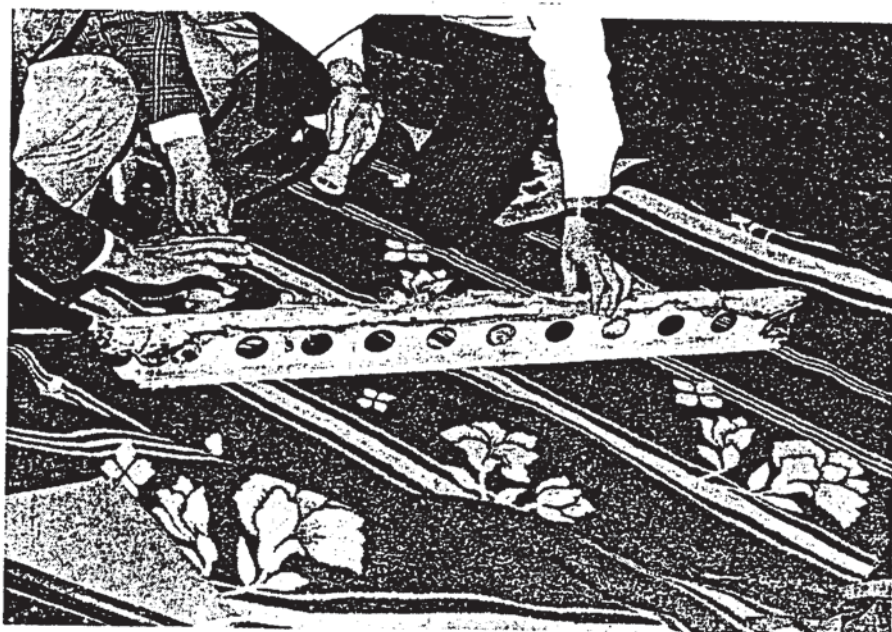
19 Wreckage discovered on flight path (3)

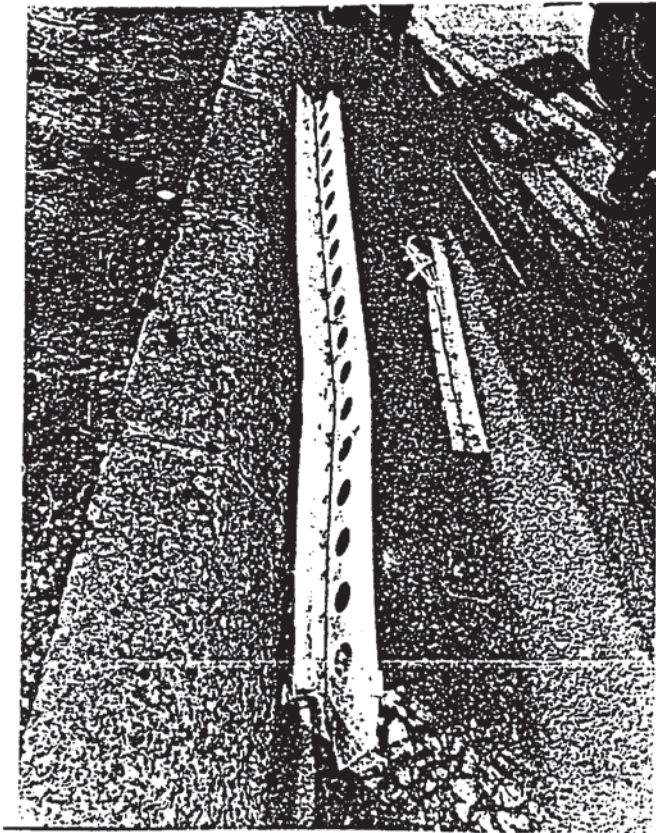
20 Wreckage discovered on flight path (4)

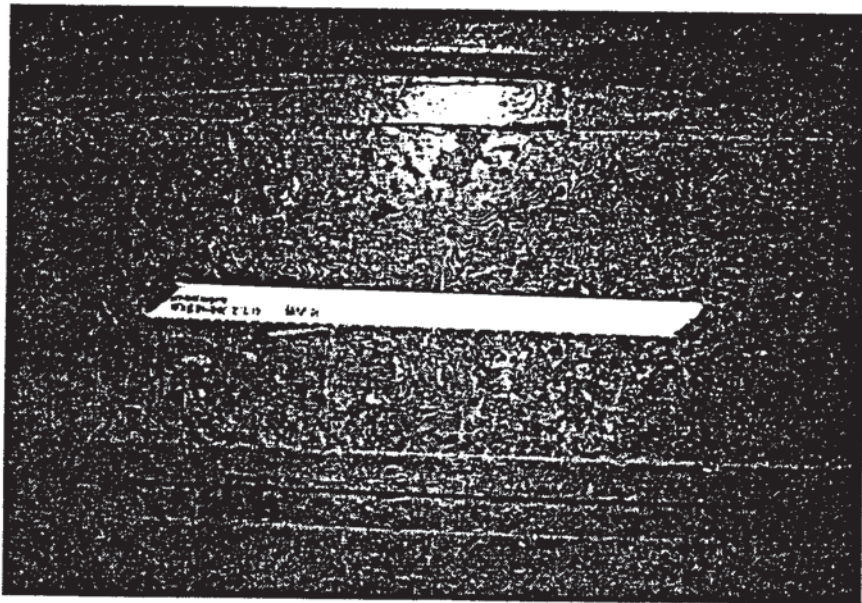
21 Reconstruction of aft fuselage (left side)

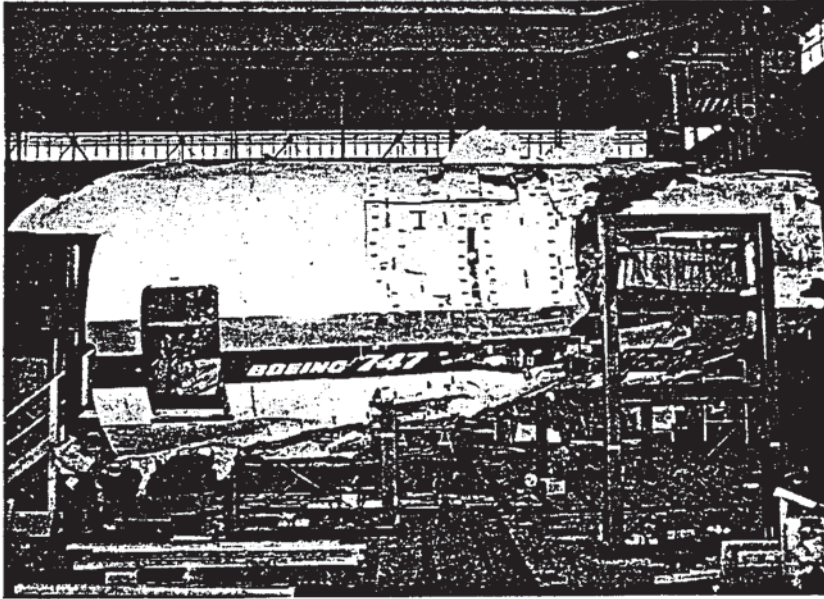
22 Reconstruction of aft fuselage (right side)

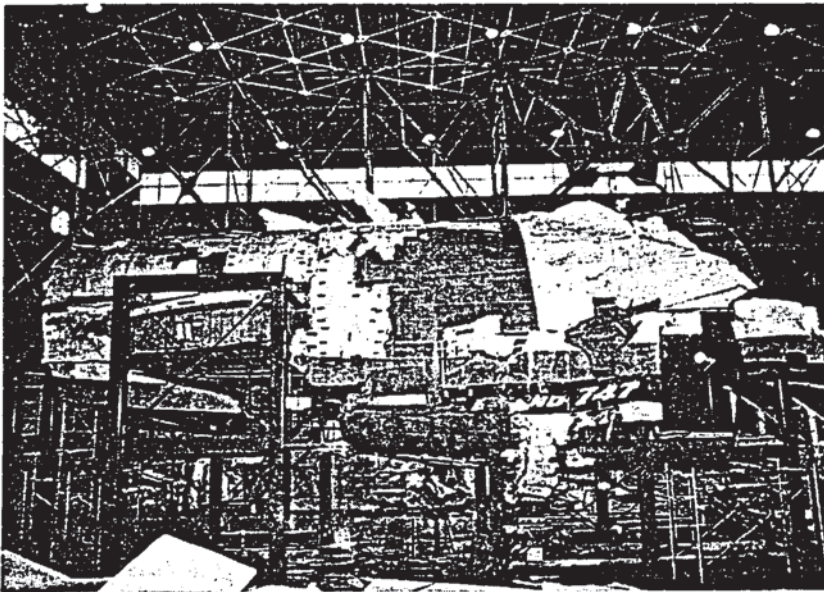
23 Vertical fin spread view

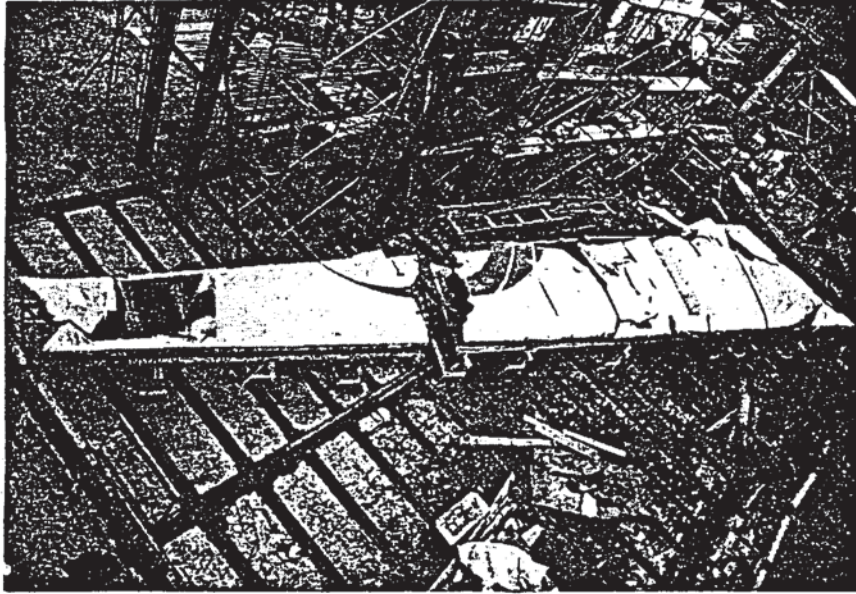
24 Reconstruction of aft pressure bulkhead

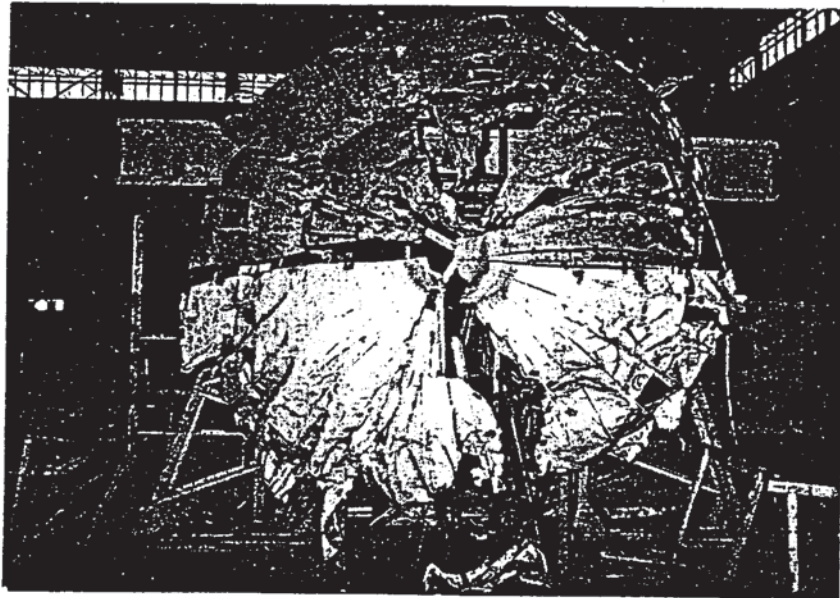
25 Pressure relief door

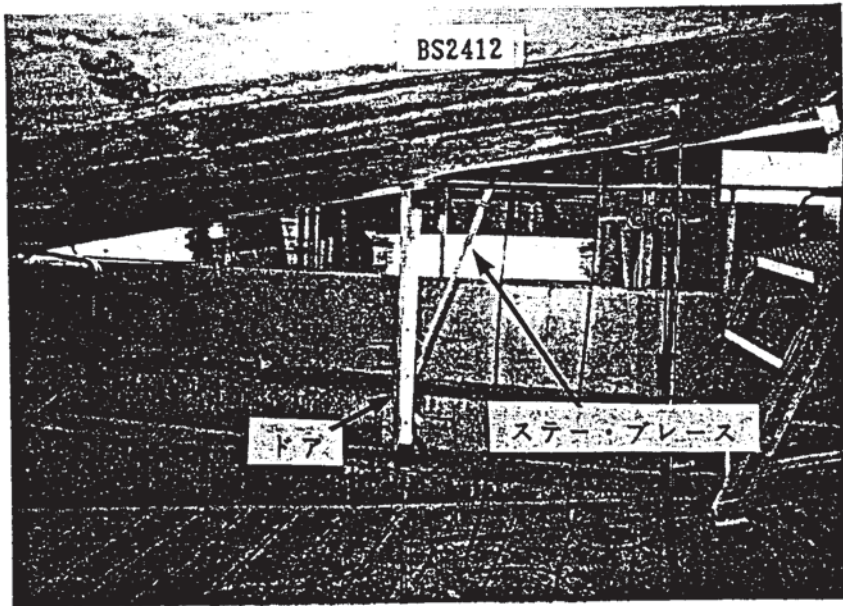
26 Pressure relief door (outside)

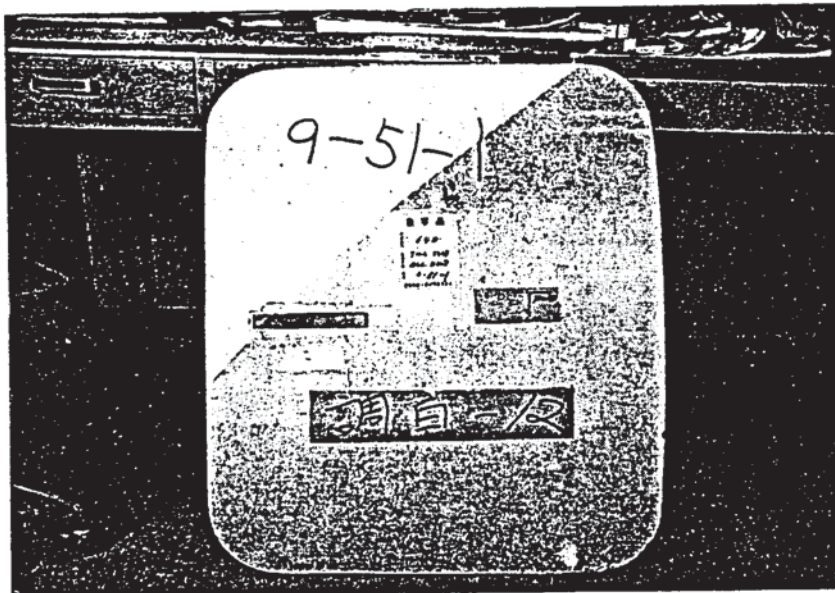
27 Pressure relief door (inside)

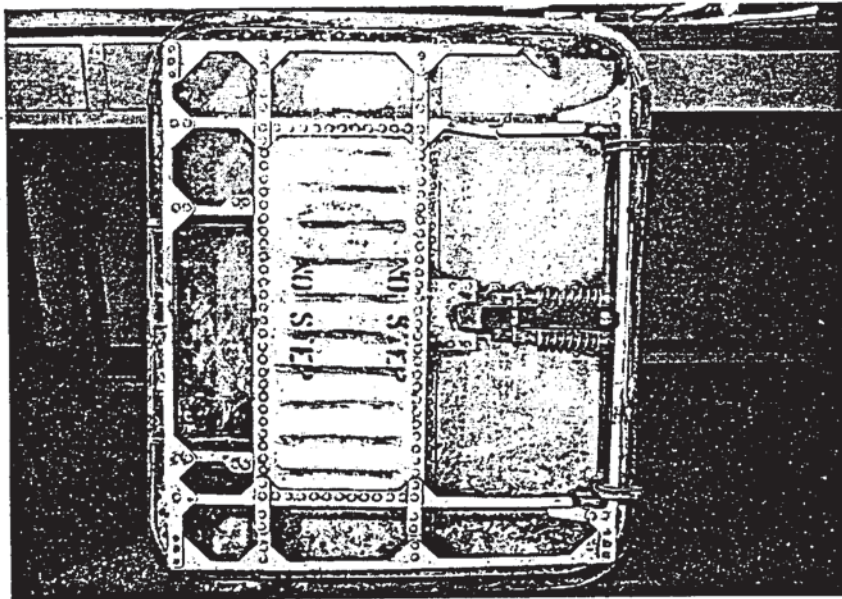
28 Deformation of skin at left door hinge of pressure relief door

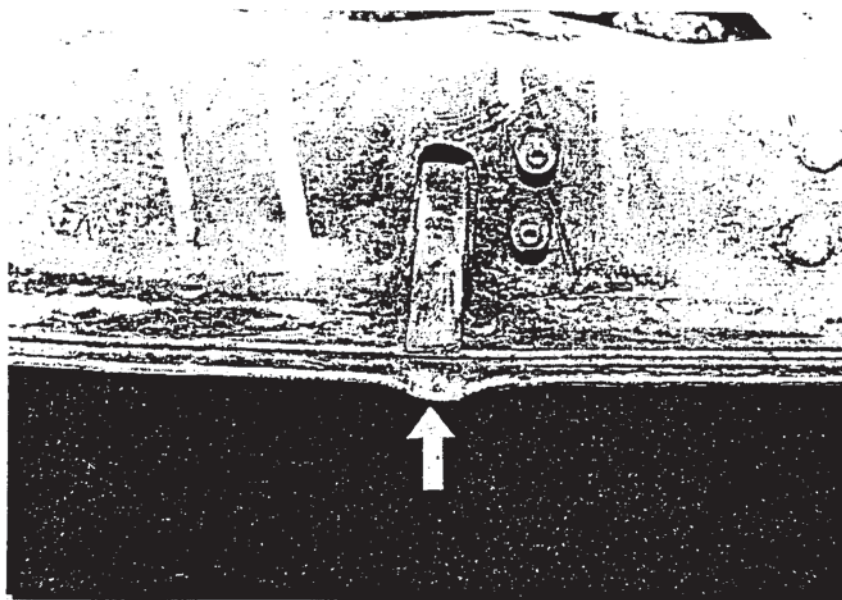
29 Deformation of skin at right door hinge
of pressure relief door

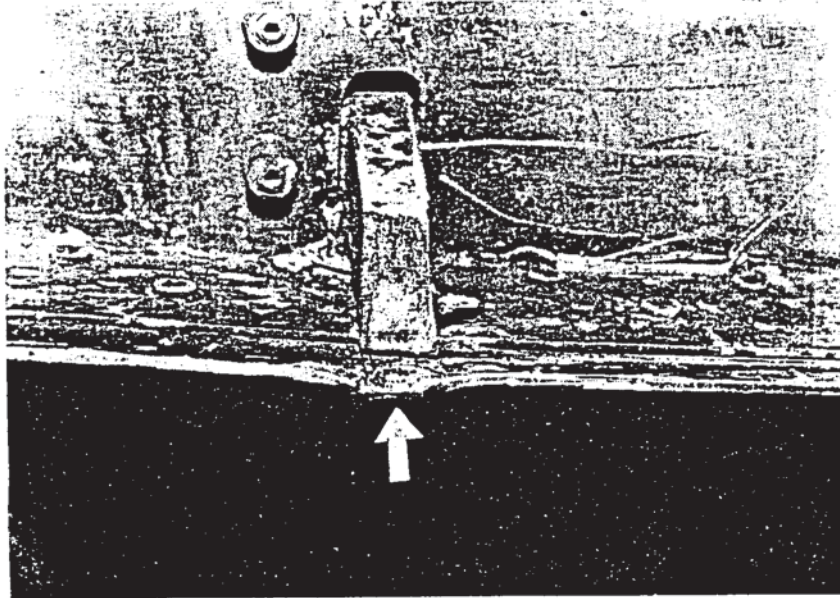
30 Abrasion on the shoulder nut of
the pressure relief door (left side)

これらの傷は、分解作業のため発生したものである。

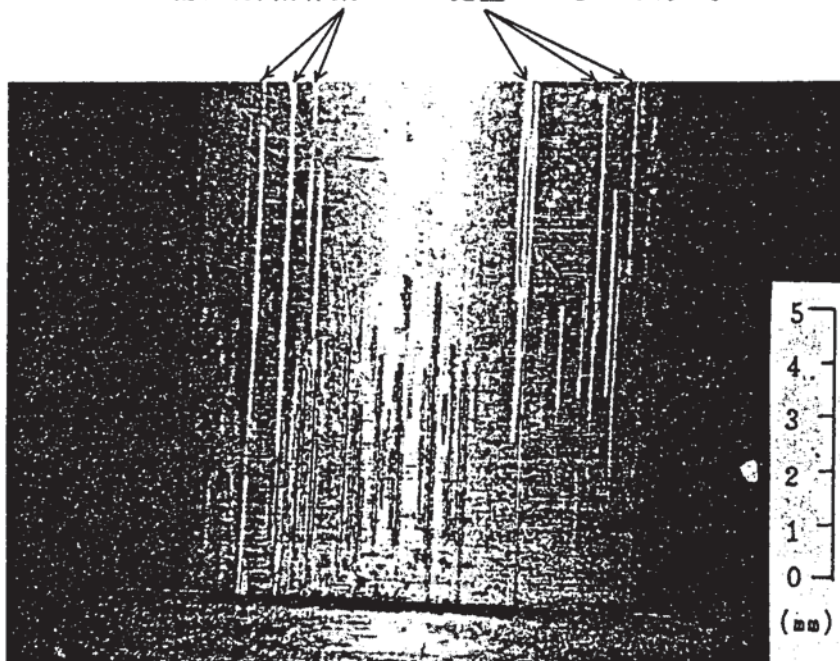
31 Abrasion on the shoulder nut of
the pressure relief door (right side)

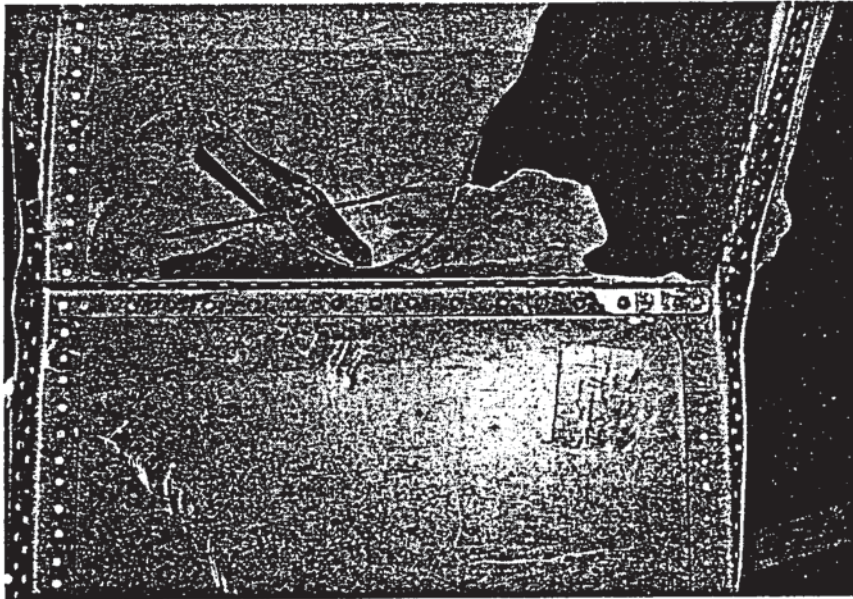
50 Vertical stabilizer front spar rib angle at FS520

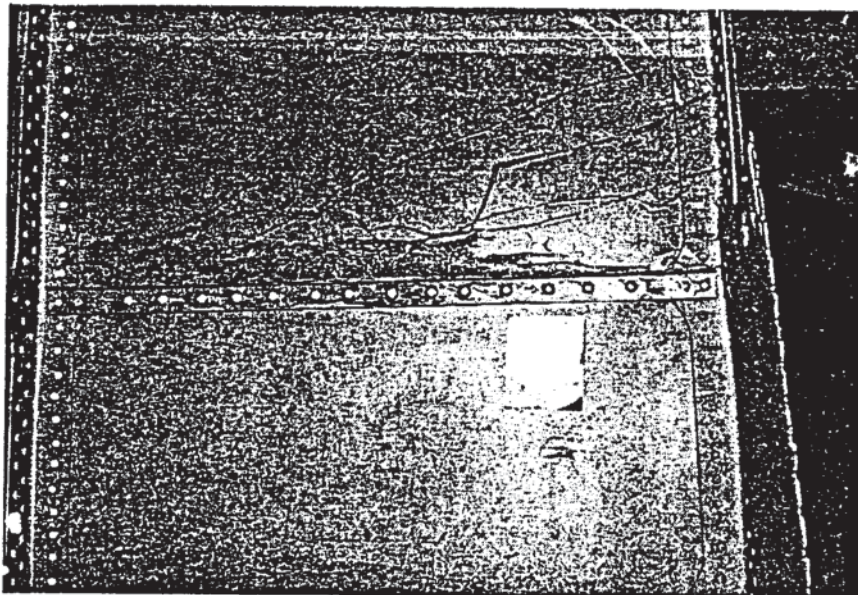
51 Vertical stabilizer front spar rib angle at FS195

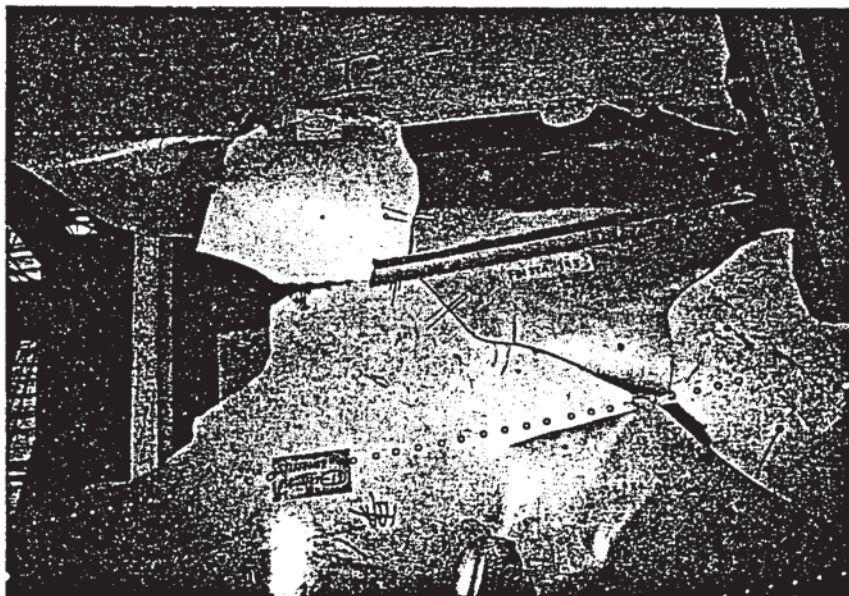
52 Vertical stabilizer front spar rib angle at FS169

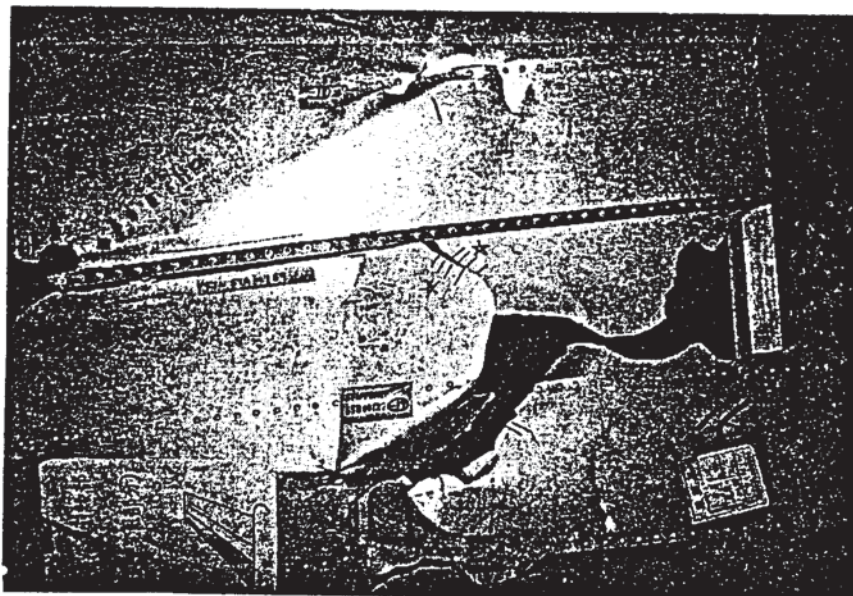
53 Scratches on vertical stabilizer front spar near FS445

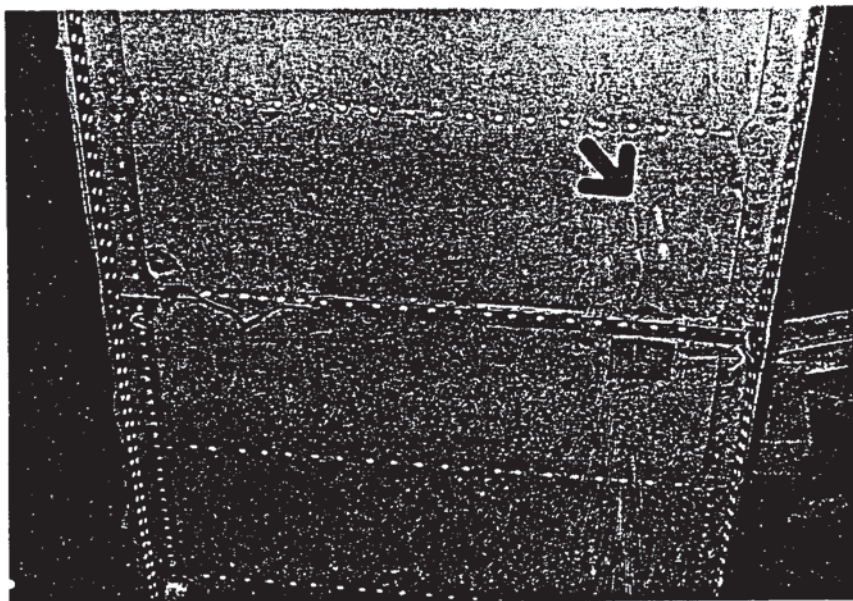
54 Scratches on vertical stabilizer front spar near FS420

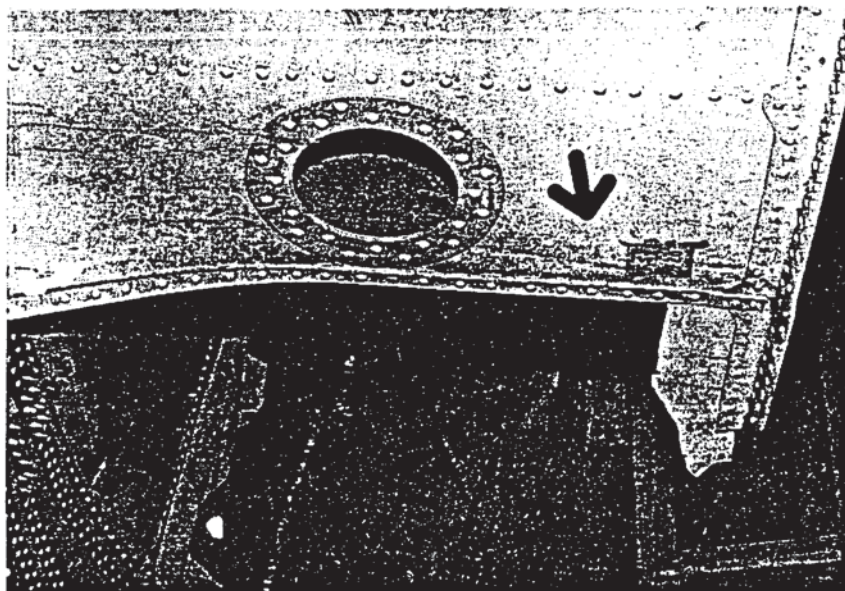
55 Scratches on vertical stabilizer front spar near FS220

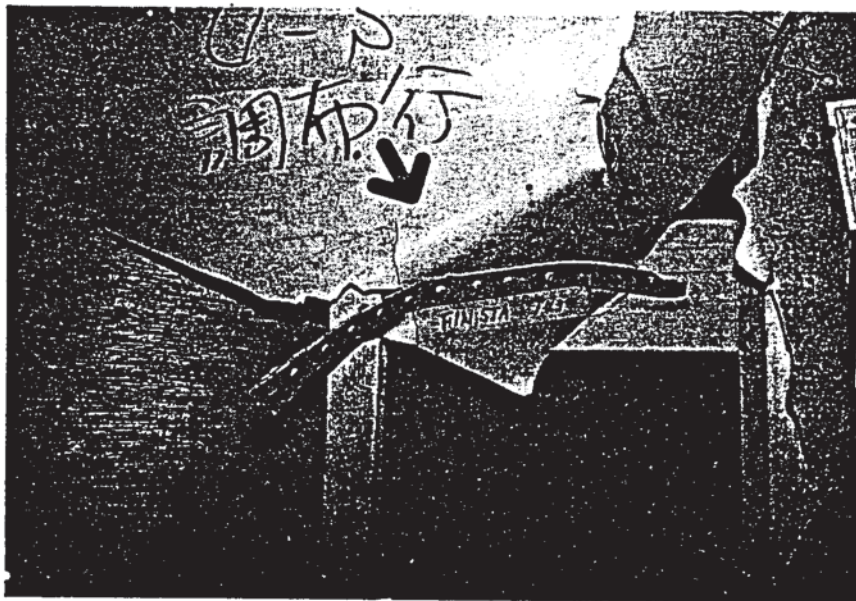
58 Black substance adhering to right side skin of vertical stabilizer (1)

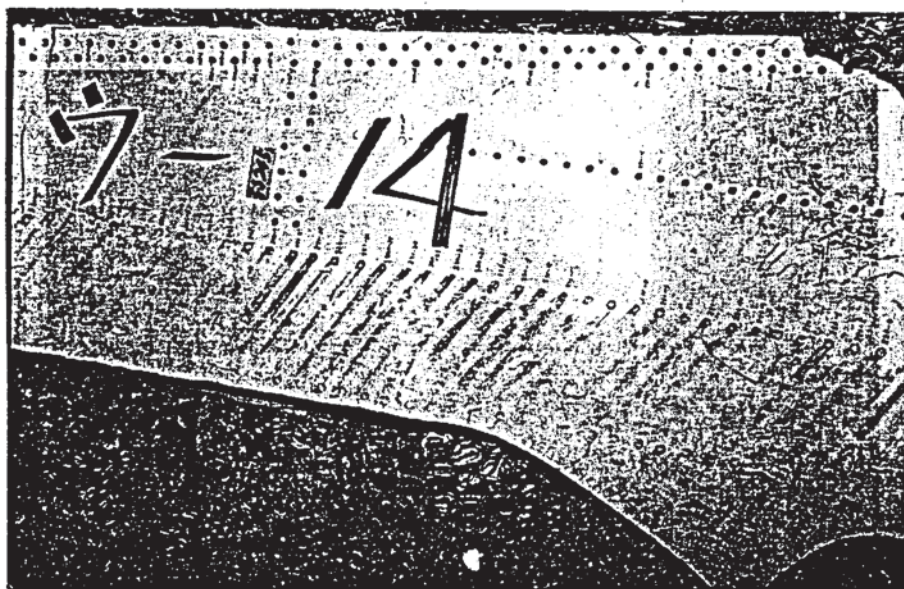
59 Black substance adhering to right side skin of vertical stabilizer (2)

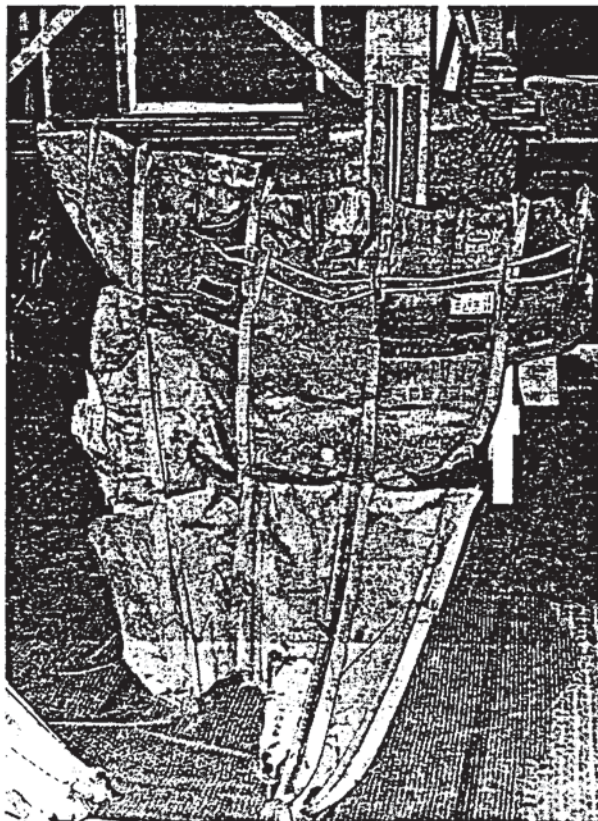
65 Aft pressure bulkhead part 1 (nonpressurized side)
